City of Kalgoorlie-Boulder

# Asbestos Management Plan

286 Hannan Street,  
Kalgoorlie WA 6430

10 March 2025

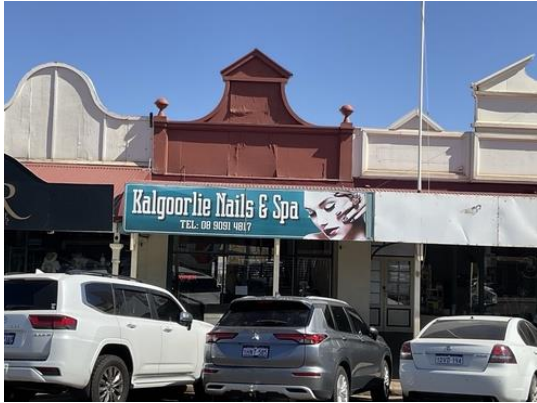
Photo 1

| City of Kalgoorlie-Boulder Asbestos Register | | | | | | | | | | | | | | | | | | | | |
|---|---|---|---|---|---|---|---|---|---|---|---|---|---|---|---|---|---|---|---|---|
| 10/03/2025 | - 286 Hannan Street, Kalgoorlie WA 6430 | 263 | N/A | Internal Electrical Switchboard | Panel | 0.5 | YES | Intact, not friable | No, if undisturbed | LOW | Monitor for wear and damages | Removal by a licenced asbestos contractor during refurbishment or demolition | Yes, before disturbed | No | Yes | Katherine Kempin | Monitor in place | N/A | Property Coordinator | 10/03/2030 |

Monitor and review for wear and damages  
Removal by a licenced asbestos contractor during refurbishment or demolition

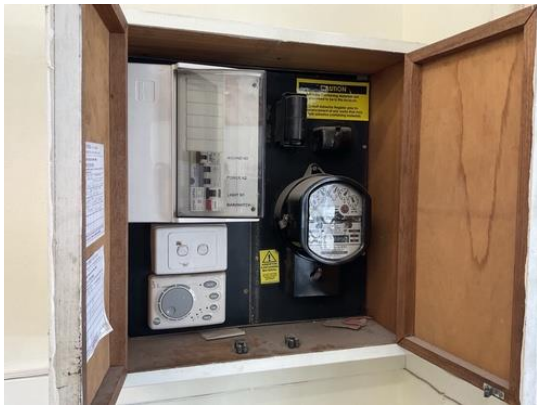
Photo 3

| City of Kalgoorlie-Boulder Asbestos Register | | | | | | | | | | | | | | | | | | | | |
|---|---|---|---|---|---|---|---|---|---|---|---|---|---|---|---|---|---|---|---|---|
| 10/03/2025 | - 286 Hannan Street, Kalgoorlie WA 6430 | 263 | N/A | External Electrical Switchboard | Panel | 0.5 | YES | Intact, not friable | No, if undisturbed | LOW | Monitor for wear and damages | Removal by a licenced asbestos contractor during refurbishment or demolition | Yes, before disturbed | No | Yes | Katherine Kempin | Monitor in place | N/A | Property Coordinator | 10/03/2030 |

Monitor and review for wear and damages  
Removal by a licenced asbestos contractor during refurbishment or demolition
