# Asbestos Management Plan

Vacant Property –  
262 Hannan Street,  
Kalgoorlie WA 6430

10 March 2025

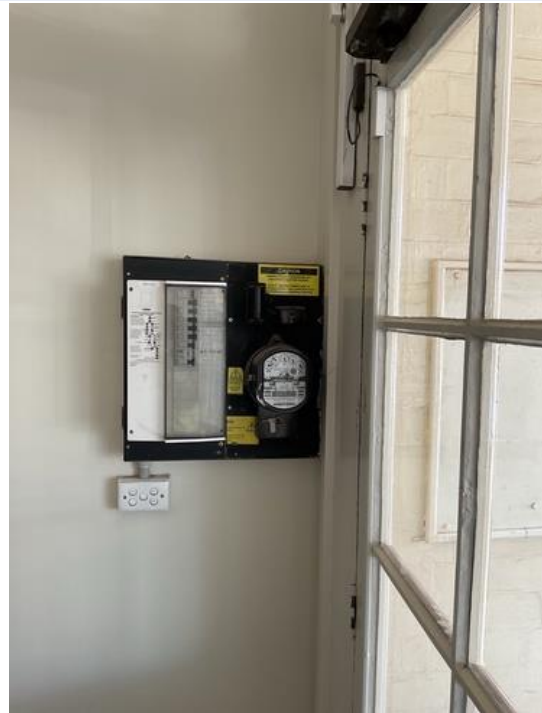
Photo 2

| City of Kalgoorlie-Boulder Asbestos Register | | | | | | | | | | | | | | | | | | | | |
|---|---|---|---|---|---|---|---|---|---|---|---|---|---|---|---|---|---|---|---|---|
| 10/03/2025 | Vacant Property - 262 Hannan Street, Kalgoorlie WA 6430 | 256 | N/A | Internal Electrical Switchboard | Panel | 0.5 | YES | Intact, not friable | No, if undisturbed | LOW | Monitor for wear and damages | Removal by a licenced asbestos contractor during refurbishment or demolition | Yes, before disturbed | No | Yes | Katherine Kempin | Monitor in place | N/A | Property Coordinator | 10/03/2030 |

- Refresh ACM sticker
- Monitor and review for wear and damages
- Removal by a licenced asbestos contractor during refurbishment or demolition
