City of Kalgoorlie-Boulder

Asbestos Management Plan

Wallace Park Cricket Oval –
401 Bourke Street,
Piccadilly, WA 6430

Site Inspection for Asbestos Containing Materials

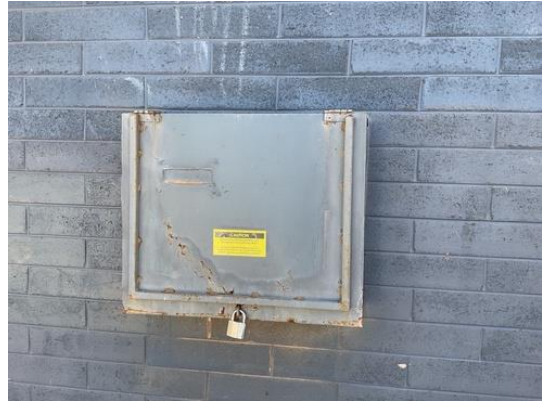
Photo 2

External Electrical Switchboard

Assumed ACM

ACM suspected

Zemolite

Condition

Low

Presumed intact unable to access

Non-Friable

Consider safe removal & replace
with non ACM

Monitor and Review the ACM's
condition

Consider safely sampling the ACM for
verification

Signify ACM present

Monitor and review for wear and damages

Removal to be completed by a licenced asbestos contractor during refurbishment or demolition

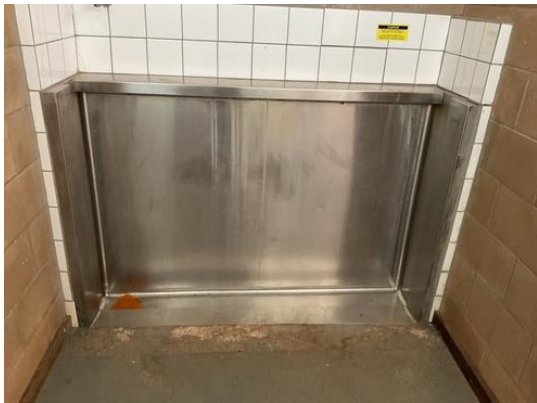
Photo 3

Assumed ACM

Condition

Is this an inaccessible area?Only accessed by maintenance staff
/ contractors**Actions for consideration:**Consider safe removal & replace
with non ACMMonitor and Review the ACM's
conditionConsider safely sampling the ACM for
verification

Monitor and review for wear and damages
