City of Kalgoorlie-Boulder

# Asbestos Management Plan

Depot Buildings –  
20 Throssell Street  
Kalgoorlie, WA 6430

11 March 2025

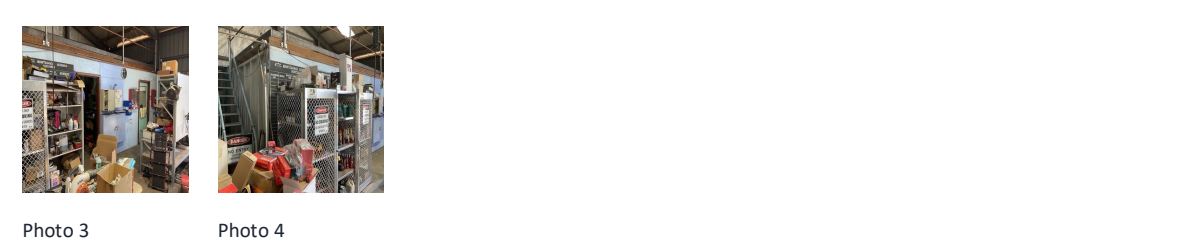
**Describe location of the ACM/Presumed ACM** Office & Stores Panels

**Assumed ACM**

| <b>Asbestos Containing Material</b> | | ACM suspected |
| <b>Material type</b> | | Hardiflex sheeting |
