City of Kalgoorlie-Boulder

# Asbestos Management Plan

Loopline Park Caretaker House—  
Lot 3405 Hamilton Street,  
Boulder, WA 6432

24 March 2025

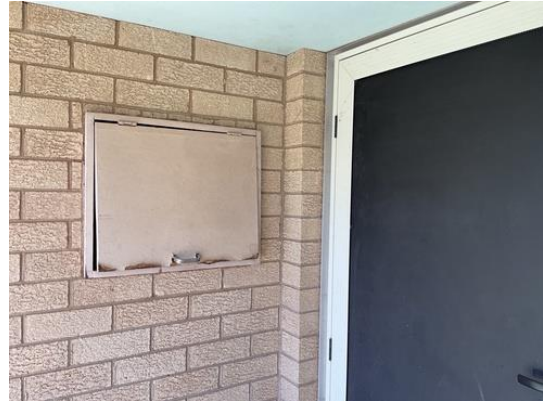
Photo 1

| City of Kalgoorlie-Boulder Asbestos Register | | | | | | | | | | | | | | | | | | | | |
|---|---|---|---|---|---|---|---|---|---|---|---|---|---|---|---|---|---|---|---|---|
| 24/03/2025 | Loopline Park Caretakers House - Lot 3405 Hamilton Street, Boulder WA 6432 | 91 | N/A | Electrical Switchboard | Electrical Switchboard | 0.5 | YES | Intact, not friable | No, if undisturbed | LOW | Monitor for wear and damages | Removal by a licenced asbestos contractor during refurbishment or demolition | Yes, before disturbed | No | Yes | Katherine Kempin | Monitor in place | N/A | Property Coordinator | 24/03/2030 |

Monitor and review for wear and damages
