City of Kalgoorlie-Boulder

# Asbestos Management Plan

Community Fair Society –  
YMCA Way,  
Boulder WA 6432

27 March 2025

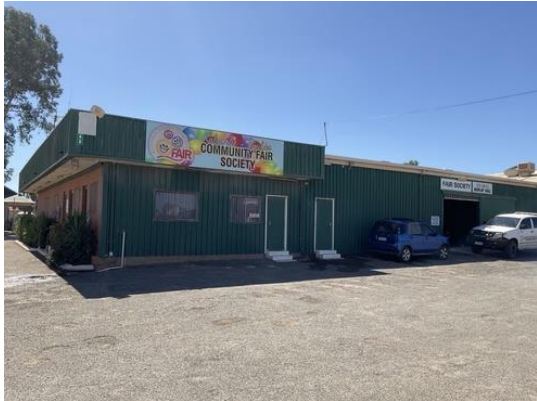
Photo 1

| City of Kalgoorlie-Boulder Asbestos Register | | | | | | | | | | | | | | | | | | | | |
|---|---|---|---|---|---|---|---|---|---|---|---|---|---|---|---|---|---|---|---|---|
| 27/03/2025 | Community Fair Society - Cruickshank Sports Arena - YMCA Way, Boulder WA 6433 | Unknown | N/A | Kitchen Sink | Blackjack Spray Resin | 2 | YES | Intact, not friable | No, if undisturbed | LOW | Monitor for wear and damages | Removal to be completed by a licenced asbestos contractor during refurbishment or demolition | Yes, before disturbed | No | Yes | Katherine Kempin | Monitor in place | N/A | Property Coordinator | 27/03/2030 |

**Details on Condition:** Intact

Monitor and review for wear and damages
