City of Kalgoorlie-Boulder

# Asbestos Management Plan

308 Hannan Street,  
Kalgoorlie WA 6430

10 March 2025

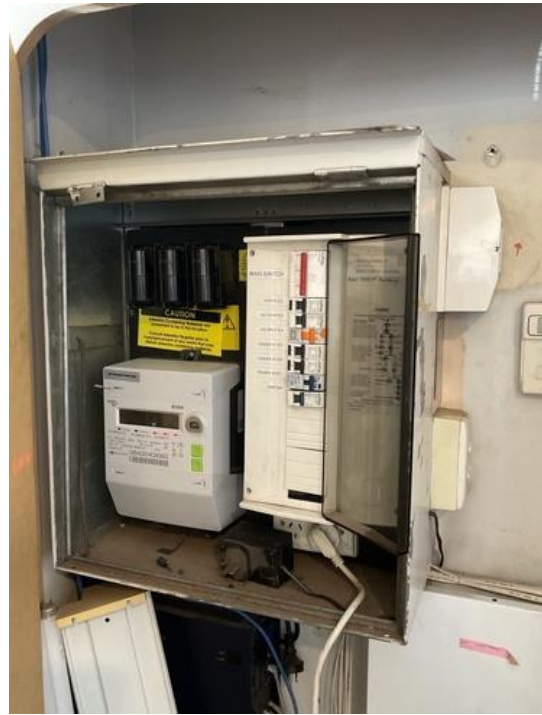
Photo 1

| City of Kalgoorlie-Boulder Asbestos Register | | | | | | | | | | | | | | | | | | | | |
|---|---|---|---|---|---|---|---|---|---|---|---|---|---|---|---|---|---|---|---|---|
| 10/03/2025 | 308 Hannan Street, Kalgoorlie WA 6430 | 272 | N/A | Internal Electrical Switchboard | Panel | 0.5 | YES | Intact, not friable | No, if undisturbed | LOW | Monitor for wear and damages | Removal by a licenced asbestos contractor during refurbishment or demolition | Yes, before disturbed | No | Yes | Katherine Kempin | Monitor in place | N/A | Property Coordinator | 10/03/2030 |

Monitor and review for wear and damages  
Removal by a licenced asbestos contractor during refurbishment or demolition
