City of Kalgoorlie-Boulder

# Asbestos Management Plan

304 Hannan Street,  
Kalgoorlie WA 6430

10 March 2025

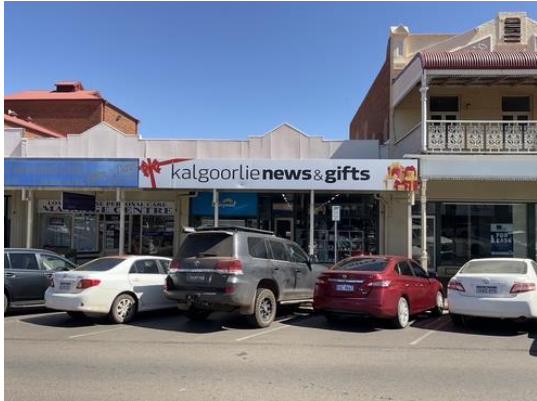
Photo 1

| City of Kalgoorlie-Boulder Asbestos Register | | | | | | | | | | | | | | | | | | | | |
|---|---|---|---|---|---|---|---|---|---|---|---|---|---|---|---|---|---|---|---|---|
| 10/03/2025 | 304 Hannan Street, Kalgoorlie WA 6430 | 271 | N/A | External Electrical Switchboard | 2 x Panels | 0.5 | YES | Intact, not friable | No, if undisturbed | LOW | Monitor for wear and damages | Removal by a licenced asbestos contractor during refurbishment or demolition | Yes, before disturbed | No | Yes | Katherine Kempin | Monitor in place | N/A | Property Coordinator | 10/03/2030 |

Monitor and review for wear and damages  
Removal by a licenced asbestos contractor during refurbishment or demolition
