# Asbestos Management Plan

Vacant Property –  
300 Hannan Street,  
Kalgoorlie WA 6430

11 March 2025

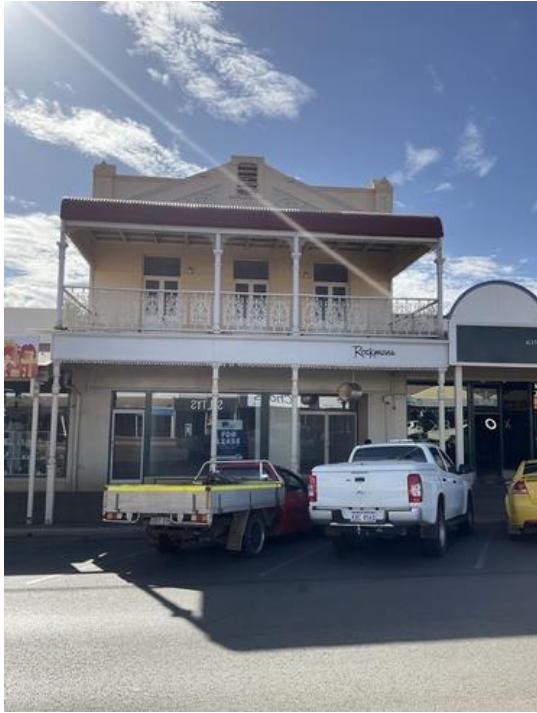
Photo 1

| City of Kalgoorlie-Boulder Asbestos Register | | | | | | | | | | | | | | | | | | | | |
|---|---|---|---|---|---|---|---|---|---|---|---|---|---|---|---|---|---|---|---|---|
| 11-Mar-25 | Vacant Property - 300 Hannan Street, Kalgoorlie WA 6430 | 270 | N/A | Rear Lower-Level Flooring | ACM vinyl tiles | 50 | YES | Intact, not friable | No, if undisturbed | LOW | Monitor for wear and damages | Removal by a licenced asbestos contractor during refurbishment or demolition | Yes, before disturbed | No | Yes | Katherine Kempin | Monitor in place | 1/01/2030 | Property Coordinator | 11/03/2030 |

Monitor and review for wear and damages
