City of Kalgoorlie-Boulder

# Asbestos Management Plan

298 Hannan Street  
Kalgoorlie WA  
6430

10 March 2025

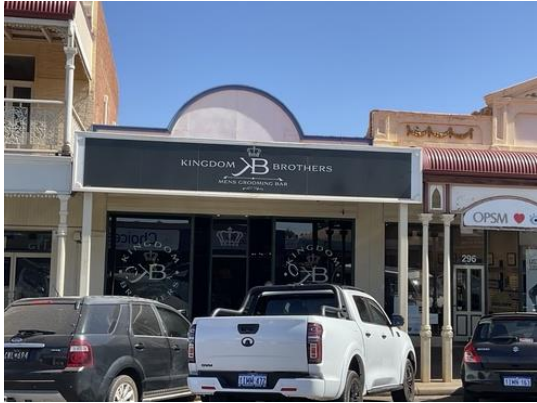
Photo 1

| City of Kalgoorlie-Boulder Asbestos Register | | | | | | | | | | | | | | | | | | | | |
|---|---|---|---|---|---|---|---|---|---|---|---|---|---|---|---|---|---|---|---|---|
| 10/03/2025 | 298 Hannan Street, Kalgoorlie WA 6430 | 269 | N/A | External Electrical Switchboard | Panel | 0.5 | YES | Intact, not friable | No, if undisturbed | LOW | Monitor for wear and damages | Removal by a licenced asbestos contractor during refurbishment or demolition | Yes, before disturbed | No | Yes | Katherine Kempin | Monitor in place | N/A | Property Coordinator | 10/03/2030 |

**Asbestos Containing Material** ACM suspected  
**Material type** Zemolite  
**Condition** Good  
**Details on Condition:** Intact  
**Quantity sqm (apx)** .5  
**Friable or Non-Friable** Non-Friable  
**Is this an inaccessible area?** Only accessed by maintenance staff / contractors

- Refresh ACM sticker
- Monitor and review for wear and damages
- Removal by a licenced asbestos contractor during refurbishment or demolition
