City of Kalgoorlie-Boulder

# Asbestos Management Plan

Rad & Rose Boutique –  
288 Hannan Street,  
Kalgoorlie WA 6430

10 March 2025

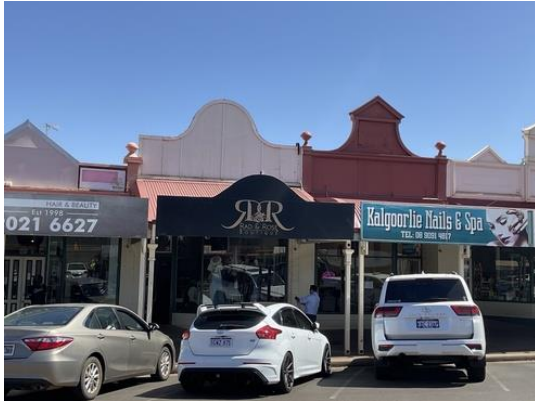
Photo 1

| City of Kalgoorlie-Boulder Asbestos Register | | | | | | | | | | | | | | | | | | | | |
|---|---|---|---|---|---|---|---|---|---|---|---|---|---|---|---|---|---|---|---|---|
| 10/03/2025 | Rad & Rose Boutique - 288 Hannan Street, Kalgoorlie WA 6430 | 264 | N/A | External Electrical Switchboard | Panel | 0.5 | YES | Intact, not friable | No, if undisturbed | LOW | Monitor for wear and damages | Removal by a licenced asbestos contractor during refurbishment or demolition | Yes, before disturbed | No | Yes | Katherine Kempin | Monitor in place | N/A | Property Coordinator | 10/03/2030 |

Monitor and review for wear and damages  
Removal by a licenced asbestos contractor during refurbishment or demolition
