City of Kalgoorlie-Boulder

# Asbestos Management Plan

282 Hannan Street,  
Kalgoorlie WA 6430

10 March 2025

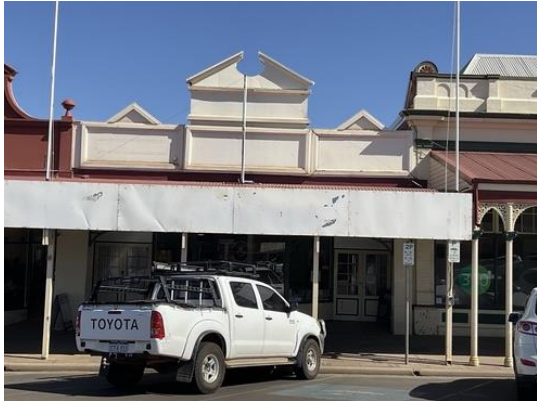
Photo 1

| City of Kalgoorlie-Boulder Asbestos Register | | | | | | | | | | | | | | | | | | | | |
|---|---|---|---|---|---|---|---|---|---|---|---|---|---|---|---|---|---|---|---|---|
| 10/03/2025 | 282 Hannan Street, Kalgoorlie WA 6430 | 262 | N/A | Internal Electrical Switchboard | Panel | 0.5 | YES | Intact, not friable | No, if undisturbed | LOW | Monitor for wear and damages | Removal by a licenced asbestos contractor during refurbishment or demolition | Yes, before disturbed | No | Yes | Katherine Kempin | Monitor in place | N/A | Property Coordinator | 10/03/2030 |

Monitor and review for wear and damages  
Removal by a licenced asbestos contractor during refurbishment or demolition
