City of Kalgoorlie-Boulder

# Asbestos Management Plan

270 Hannan Street,  
Kalgoorlie WA 6430

10 March 2025

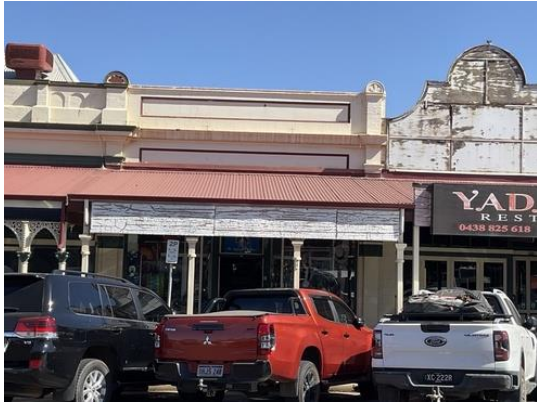
Photo 1

| City of Kalgoorlie-Boulder Asbestos Register | | | | | | | | | | | | | | | | | | | | |
|---|---|---|---|---|---|---|---|---|---|---|---|---|---|---|---|---|---|---|---|---|
| 10/03/2025 | 270 Hannan Street, Kalgoorlie WA 6430 | 260 | N/A | Internal Electrical Switchboard | Panel | 0.5 | YES | Intact, not friable | No, if undisturbed | LOW | Monitor for wear and damages | Removal by a licenced asbestos contractor during refurbishment or demolition | Yes, before disturbed | No | Yes | Katherine Kempin | Monitor in place | N/A | Property Coordinator | 10/03/2030 |

Monitor and review for wear and damages  
Removal by a licenced asbestos contractor during refurbishment or demolition
