City of Kalgoorlie-Boulder

# Asbestos Management Plan

264 Hannan Street,  
Kalgoorlie WA 6430

10 March 2025

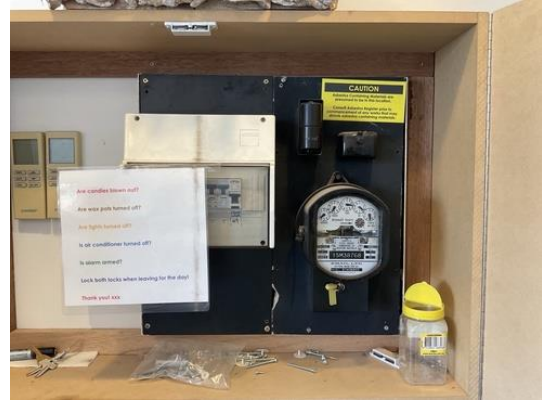
Photo 2

| City of Kalgoorlie-Boulder Asbestos Register | | | | | | | | | | | | | | | | | | | | |
|---|---|---|---|---|---|---|---|---|---|---|---|---|---|---|---|---|---|---|---|---|
| 10/03/2025 | 264 Hannan Street, Kalgoorlie WA 6430 | 257 | N/A | Internal Electrical Switchboard | Panel | 0.5 | YES | Intact, not friable | No, if undisturbed | LOW | Monitor for wear and damages | Removal by a licenced asbestos contractor during refurbishment or demolition | Yes, before disturbed | No | Yes | Katherine Kempin | Monitor in place | N/A | Property Coordinator | 10/03/2030 |

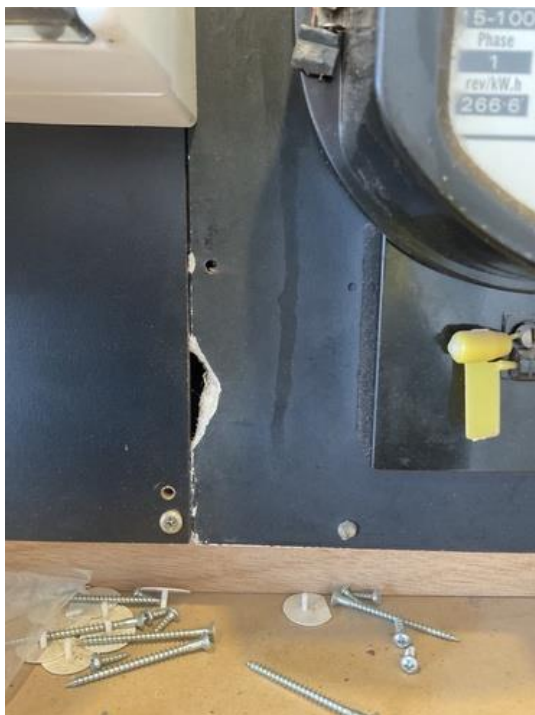
Photo 3

Seal damaged area otherwise intact

Seal damaged area  
Monitor and review for wear and damages  
Removal by a licenced asbestos contractor during refurbishment or demolition
