City of Kalgoorlie-Boulder

# Asbestos Management Plan

250 Hannan Street  
Kalgoorlie WA 6430

10 March 2025

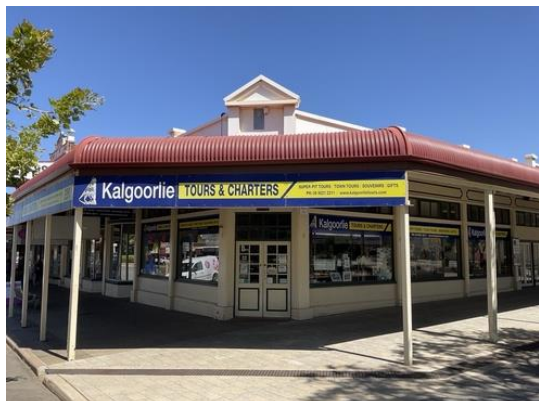
Photo 1

| City of Kalgoorlie-Boulder Asbestos Register | | | | | | | | | | | | | | | | | | | | |
|---|---|---|---|---|---|---|---|---|---|---|---|---|---|---|---|---|---|---|---|---|
| 10/03/2025 | 250 Hannan Street, Kalgoorlie WA 6430 | 251 | N/A | Internal Electrical Switchboard | Panel | 0.5 | YES | Intact, not friable | No, if undisturbed | LOW | Monitor for wear and damages | Removal to be completed by a licenced asbestos contractor during refurbishment or demolition | Yes, before disturbed | No | Yes | Katherine Kempin | Monitor in place | N/A | Property Coordinator | 11/03/2030 |

Monitor and review for wear and damages  
Removal to be completed by a licenced asbestos contractor during refurbishment or demolition
