City of Kalgoorlie-Boulder

# Asbestos Management Plan

Shop 4  
272 Hannan Street,  
Kalgoorlie, WA 6430

11 March 2025

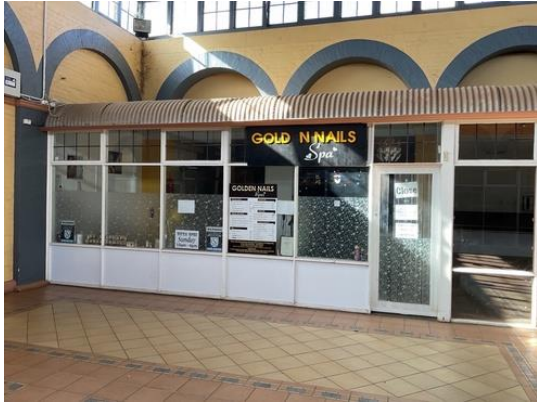
Photo 1

| City of Kalgoorlie-Boulder Asbestos Register | | | | | | | | | | | | | | | | | | | | |
|---|---|---|---|---|---|---|---|---|---|---|---|---|---|---|---|---|---|---|---|---|
| 11/03/2025 | Market Arcade Shop 4<br>272 Hannan Street, Kalgoorlie WA 6430 | 261 | N/A | Flooring | ACM Vinyl Tiles | 30 | YES | Damaged and deteriorating | Yes | MODERATE | Test the potential ACM product by the proposed remediation date. If the test result is positive, either reseal or replace with non-ACM product within 9 months of test results | Unable to lift lino to ascertain if tiles continue into shop, assumed based on front step. Use caution when replacing flooring. Removal by a licenced asbestos contractor during refurbishment or demolition | Yes, before disturbed | No | Yes | Katherine Kempin | Testing required | 1/03/2026 | Property Coordinator | 11/03/2030 |

Damaged and deteriorating

Accessible: potential to be damaged

If the test result is positive, either reseal or replace with non-ACM product within 9 months of test results
