# Asbestos Management Plan

Eastern BMX Club—  
24-28 Marshall Street,  
West Lamington, WA 6430

24 March 2025

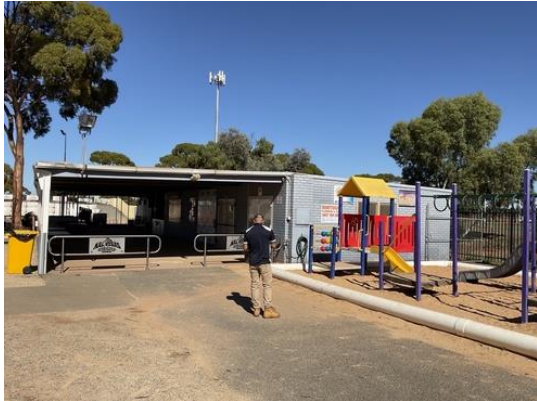
Photo 1

| City of Kalgoorlie-Boulder Asbestos Register | | | | | | | | | | | | | | | | | | | | |
|---|---|---|---|---|---|---|---|---|---|---|---|---|---|---|---|---|---|---|---|---|
| 24/03/2025 | Eastern BMX Club - 24 - 28 Marshall Street, West Lamington WA 6430 | Unknown | N/A | External Male Toilet Urinal | Blackjack Spray Resin | 2 | YES | Intact, not friable | No, if undisturbed | LOW | Monitor for wear and damages | Removal by a licenced asbestos contractor during refurbishment or demolition | Yes, before disturbed | No | Yes | Katherine Kempin | Monitor in place | N/A | Property Coordinator | 24/03/2030 |

Monitor and review for wear and damages
