# Asbestos Management Plan

Vacant Property –  
260 Hannan Street,  
Kalgoorlie WA 6430

27 March 2025

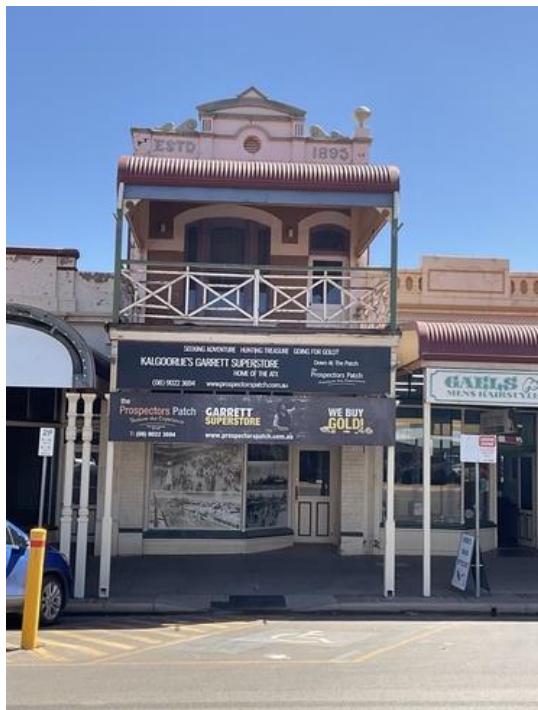
Photo 1

| City of Kalgoorlie-Boulder Asbestos Register | | | | | | | | | | | | | | | | | | | | |
|---|---|---|---|---|---|---|---|---|---|---|---|---|---|---|---|---|---|---|---|---|
| 27/03/2025 | Vacant Property - 260 Hannan Street, Kalgoorlie WA 6430 | 255 | 255 | Mezzanine Floor Kitchen Sink | Black Spray Resin | 1 | YES | Intact, not friable | No, if undisturbed | LOW | Monitor for wear and damages | Removal by a licenced asbestos contractor during refurbishment or demolition | Yes, before disturbed | No | Yes | Katherine Kempin | Monitor in place | N/A | Property Coordinator | 27/03/2030 |

Monitor and review for wear and damages  
Removal by a licenced asbestos contractor during refurbishment or demolition
