City of Kalgoorlie-Boulder

# Asbestos Management Plan

Old Coles & Kmart Site –  
Brookman-Hay Street,  
Kalgoorlie, WA 6432

27 March 2025

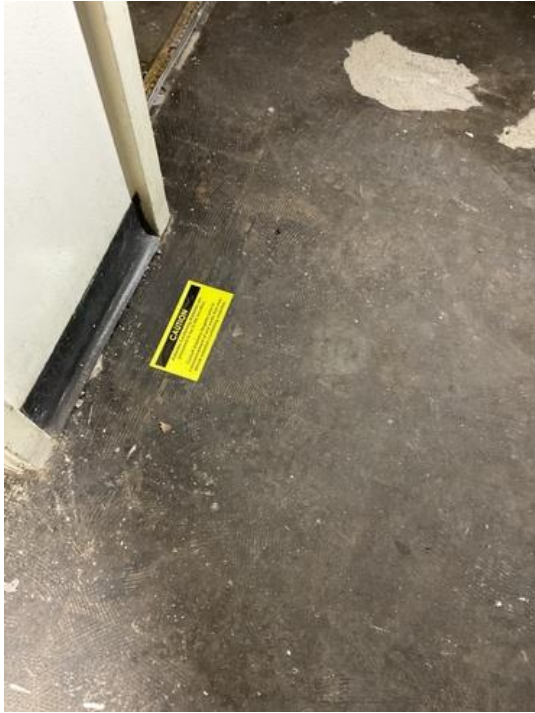
Photo 1

| City of Kalgoorlie-Boulder Asbestos Register | | | | | | | | | | | | | | | | | | | | | |
|---|---|---|---|---|---|---|---|---|---|---|---|---|---|---|---|---|---|---|---|---|--|
| 27/03/2025 | Old Coles / Kmart Site - Brookman-Hay Street, Kalgoorlie WA 6432 | Unknown | N/A | Coles - Upstairs Offices Floor | Blackjack Black Resin/Glue | 40 | YES | Damaged and deteriorating | Yes | MODERATE | Test the potential ACM product by the proposed remediation date. If the test result is positive, remove within 9 months of test results | Removal by a licenced asbestos contractor during refurbishment or demolition | Yes, before disturbed | No | Yes | Katherine Kempin | If ACM is present, remove | 27/03/2026 | Property Coordinator | 27/03/2026 | |

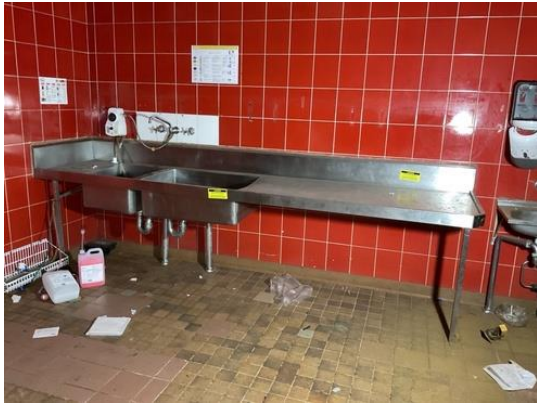
Photo 5

| City of Kalgoorlie-Boulder Asbestos Register | | | | | | | | | | | | | | | | | | | | | |
|---|---|---|---|---|---|---|---|---|---|---|---|---|---|---|---|---|---|---|---|---|--|
| 27/03/2025 | Old Coles / Kmart Site - Brookman-Hay Street, Kalgoorlie WA 6432 | Unknown | N/A | Coles - Deli Kitchen Sink | Blackjack Spray Resin | 4 | YES | Intact, not friable | No, if undisturbed | LOW | Monitor for wear and damages | Removal by a licenced asbestos contractor during refurbishment or demolition | Yes, before disturbed | No | Yes | Katherine Kempin | Monitor in place | N/A | Property Coordinator | 27/03/2030 | |
